DOT/FAA/AR-95/54

Transport Water Impact and Ditching Performance

March 1996

Final Report

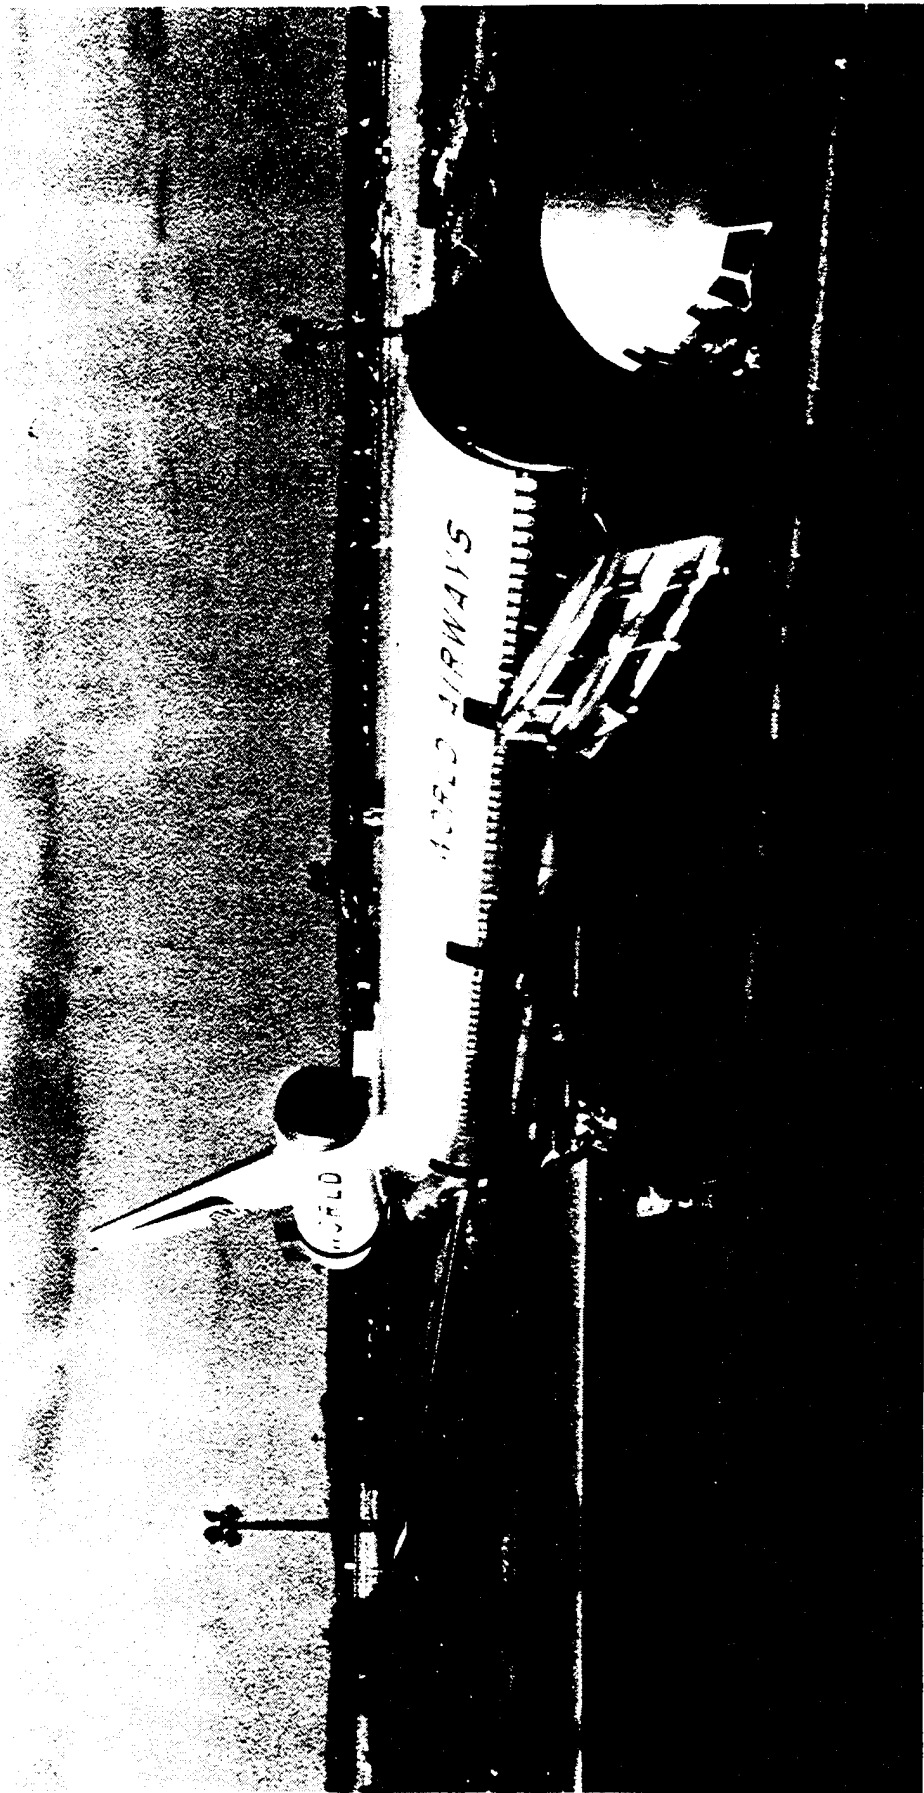
Upon crossing the end of the runway, the airplane came to rest with a slightly nosedown attitude in water which came up to the wings. A section of the nose up to the first row of the cabin seats separated along a fracture line (figure 1) and remained attached to the fuselage only by control cables and electric wire bundles. The pressure bulkhead was crushed along the fuselage bottom centerline, and the main cabin floor beams from fuselage station (FS) 392 to 475 failed due to the downward displacement. The pressure bulkhead at the forward end of the nose gear was crushed as well, leading to the failure of the extended nose gear. The main landing gear were extended and remained undamaged. The airplane's three engines remained attached to their respective pylons, although the No. 3 engine's rear mount was broken. There was no substantial mechanical damage to the engine.

FIGURE 1. WORLD AIRWAYS DC-10 AFTER COMING TO REST IN BOSTON HARBOR

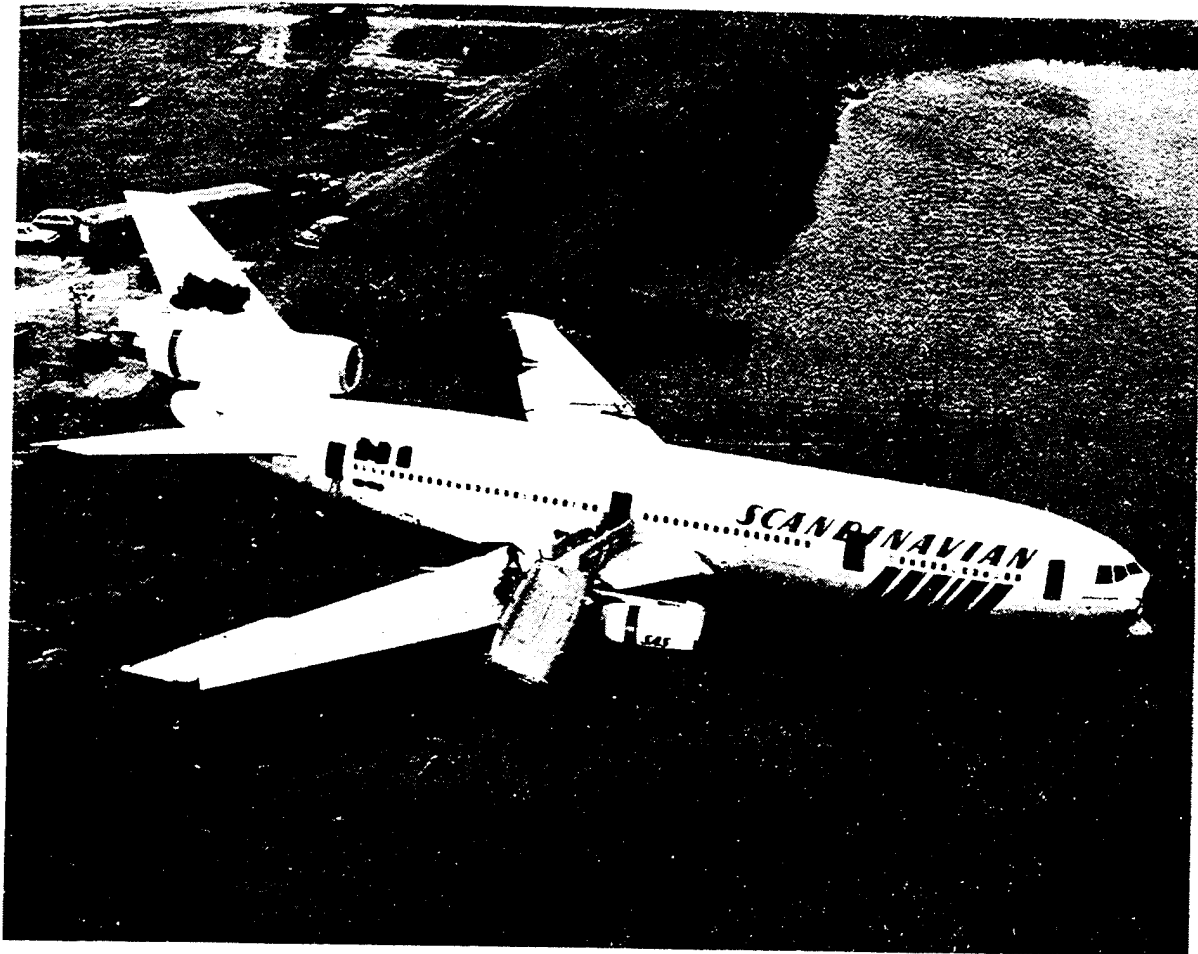
The nose of the airplane came to rest in the tidal waterway approximately 160 feet from the end of the runway overrun area (figure 2). The leading edge of the left wing was embedded in a wooden pier structure which supported the approach lighting system. The aft section of the airplane remained generally intact, however there was major damage to the lower nose area, to the radome, and to the forward pressure bulkhead at fuselage station (FS) 275. The damage was caused by hydrodynamic pressure generated during impact with the water.

FIGURE 2. JOHN F. KENNEDY AIRPORT RUNWAY GRADUAL SLOPE TO WATER

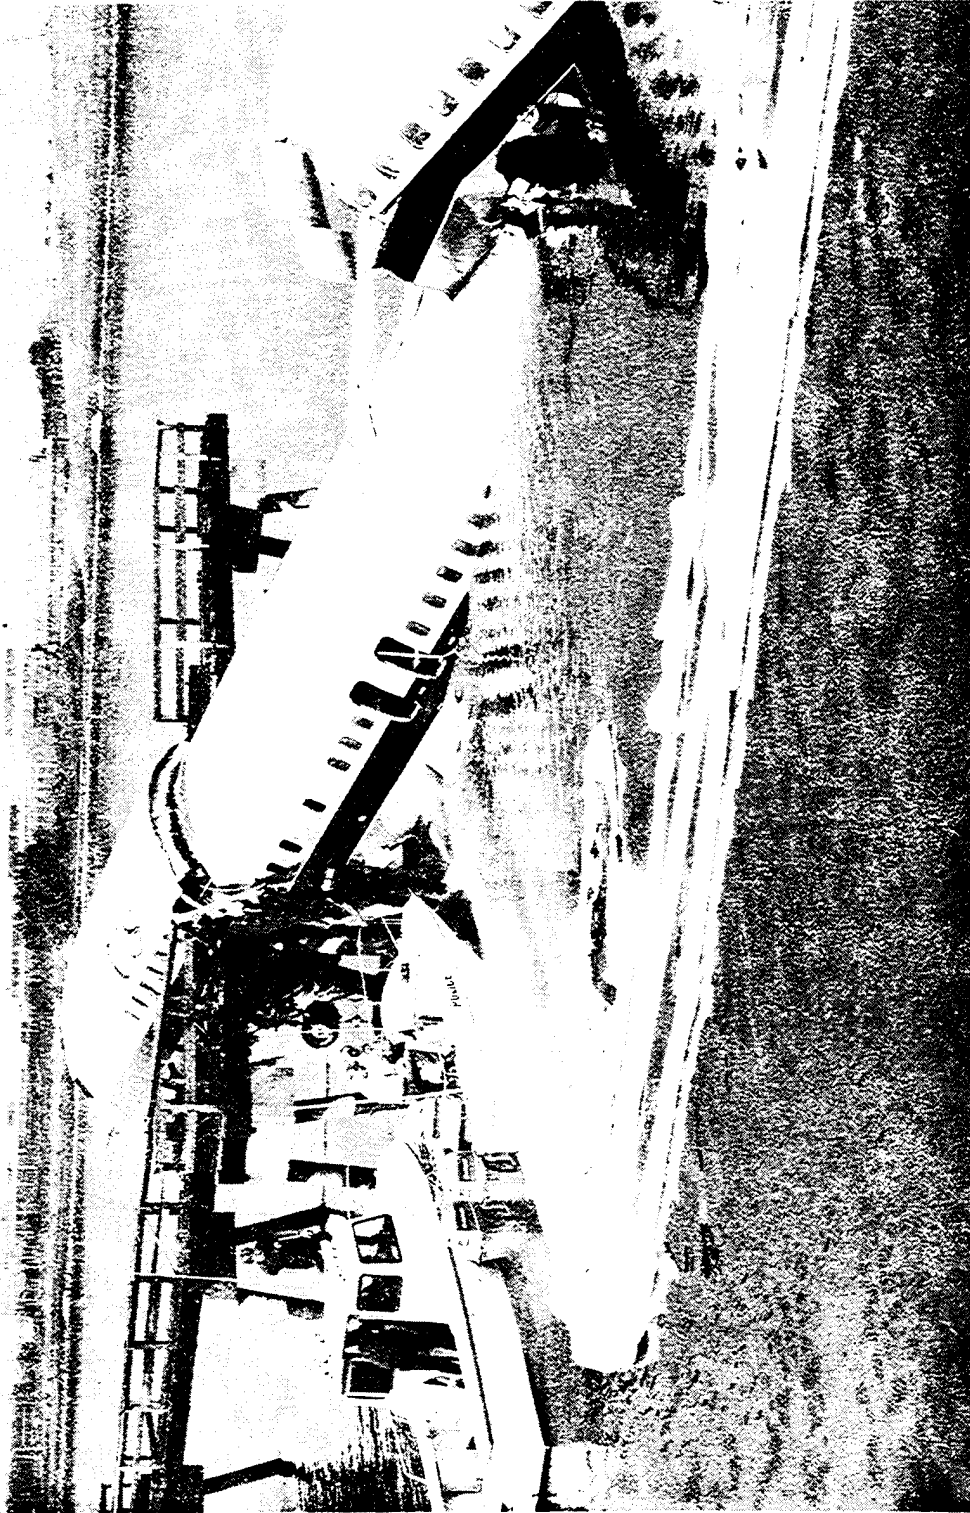
Floor displacement was the primary cause of two fatalities. Timber from the wooden approach light pier structure penetrated the fuselage and forced the floor section and surrounding seats upwards, crushing four passengers against the ceiling. Two passengers in row 21 were killed by asphyxia caused by compression of the chest and two passengers in row 22 sustained serious multiple injuries. A piece of wood also penetrated the forward cockpit bulkhead, but did not produce any seat dislocations and caused only minor injury to the captain. The airplane was equipped with eight exits (figure C-3): the L-1 main boarding door, the L-2 aft entry door, the R-1 forward galley door, the R-2 aft galley door, and four overwing exits. All exit doors, with the exception of the L-1 and L-2, were used during evacuation. The L-1 door could not be opened by the lead flight attendant, and the L-2 door was closed when water began entering the cabin. The R-1 slide was successfully deployed. The flight attendant disarmed the R-2 slide before the door was opened to prevent the slide from blocking the exit area. Both the left and right overwing exits operated successfully during evacuation.

FIGURE 3. US AIR B737-400 AFTER COMING TO REST ON LIGHTING STANCHION IN BOWERY BAY

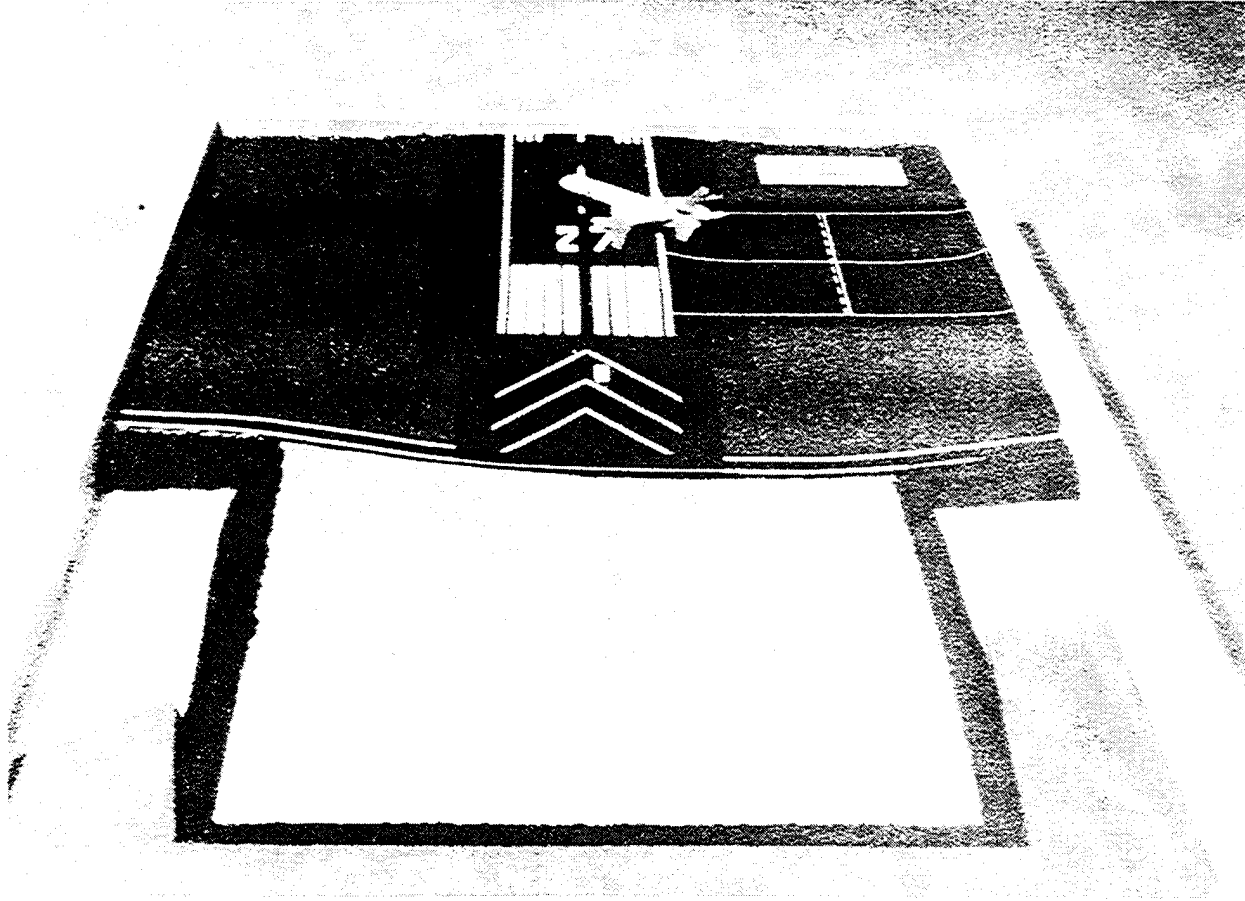
Allowing the airplane to gradually slide into water, as in the JFK accident, should result in minimal aircraft damage and a successful emergency evacuation of all occupants using the available flotation devices. Runway overrun areas leading into water which avoid sudden drop-offs and allow for a smooth transition into the water can reduce impact forces and prevent fuselage separations. Evidence to support this is provided by both the FAA and airport engineers. As stated in FAR Part 139.307 (a)(1), "No slope from the edge of the full-strength surfaces downward to the existing terrain shall be steeper than 2:1," thus preventing vertical drop-offs. Boston-Logan Airport Engineers have looked into the feasibility of developing sloped runway safety areas that decelerate the aircraft through the use of gravel. The model of such a sloped overrun area, developed by Boston-Logan Airport Engineers, is shown below in figure 4.

FIGURE 4. INCLINED SAFETY AREA (ISA) MODEL DEVELOPED BY BOSTON-LOGAN AIRPORT ENGINEERS

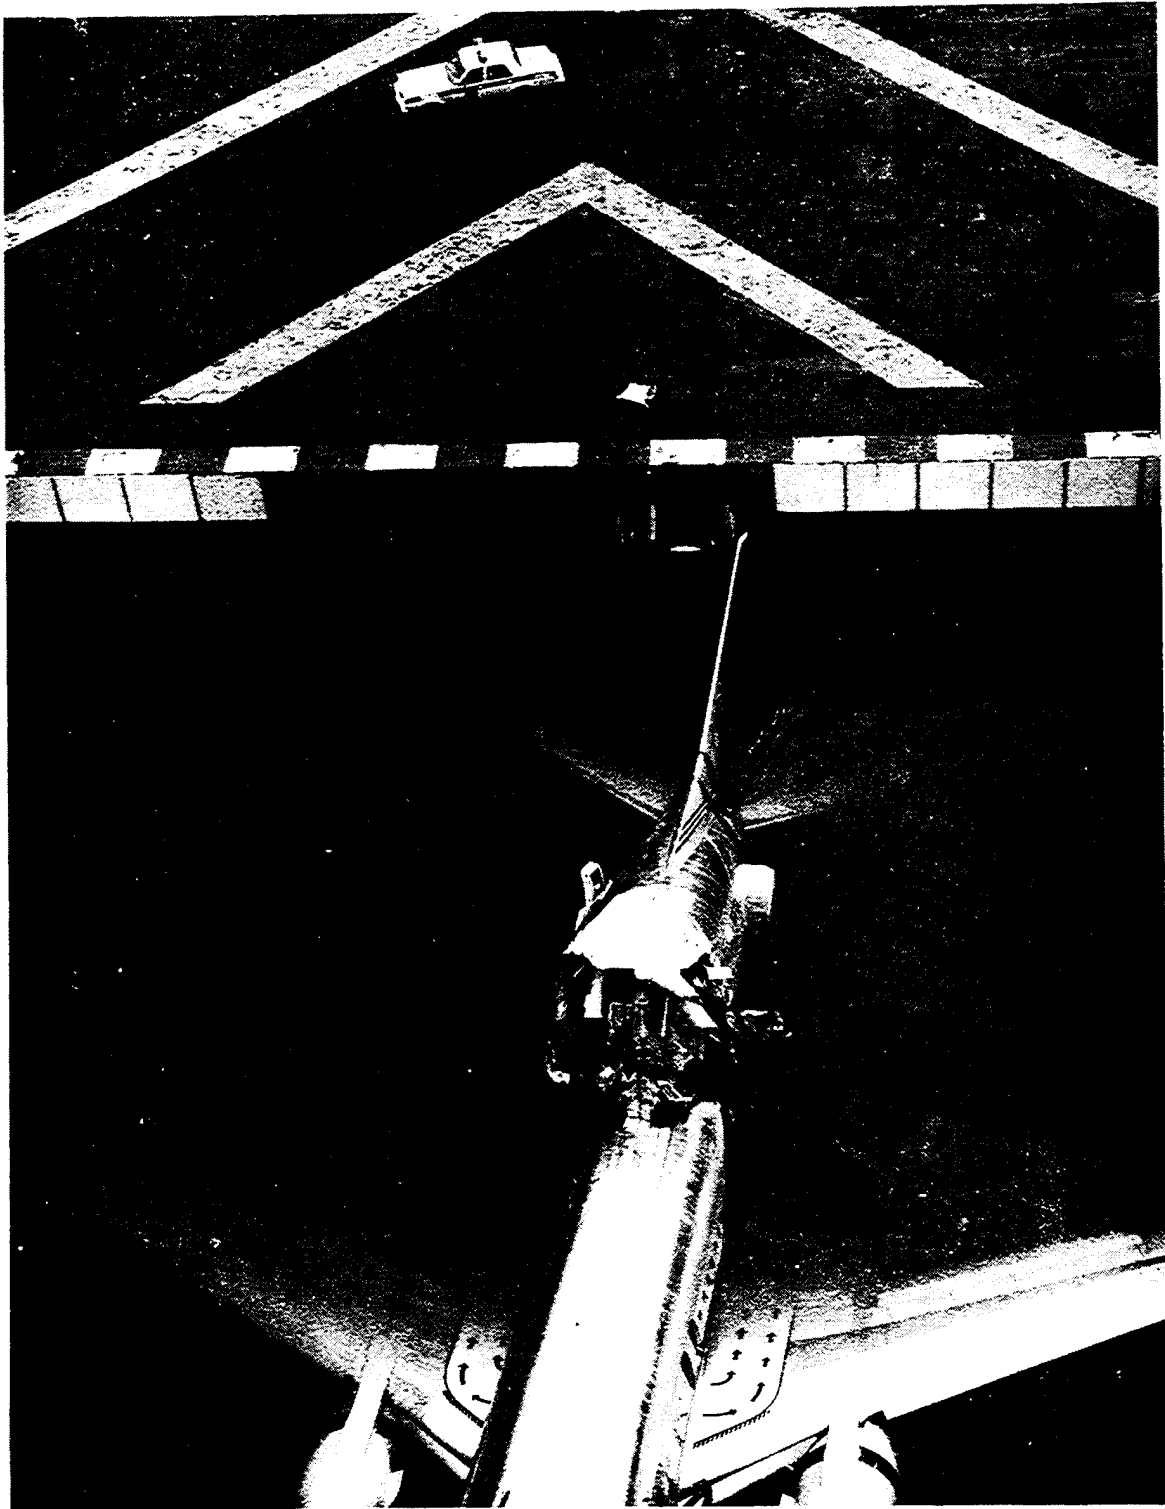
The drop into the water and the presence of obstructions immediately beyond the runway increase the potential for excessive impact forces on the airplane. The LaGuardia accident included both of these hazards. Upon crossing the end of the runway, the airplane encountered a drop of approximately 10 feet into the water and a concrete/wooden pier structure positioned within 50 feet of and in line with the end of the runway. The fuselage separated in two locations. In contrast, the JFK accident involved a very gradual slope into the water resulting in no fuselage separations. Although there was an approach lighting pier located directly beyond the runway, the landing gear remained on the ground and the pilot was able to swerve the airplane to avoid it.

FIGURE 5. LAGUARDIA AIRPORT RUNWAY DROP-OFF TO WATER
